LHC Incident

What (really) really happened on September 19th*

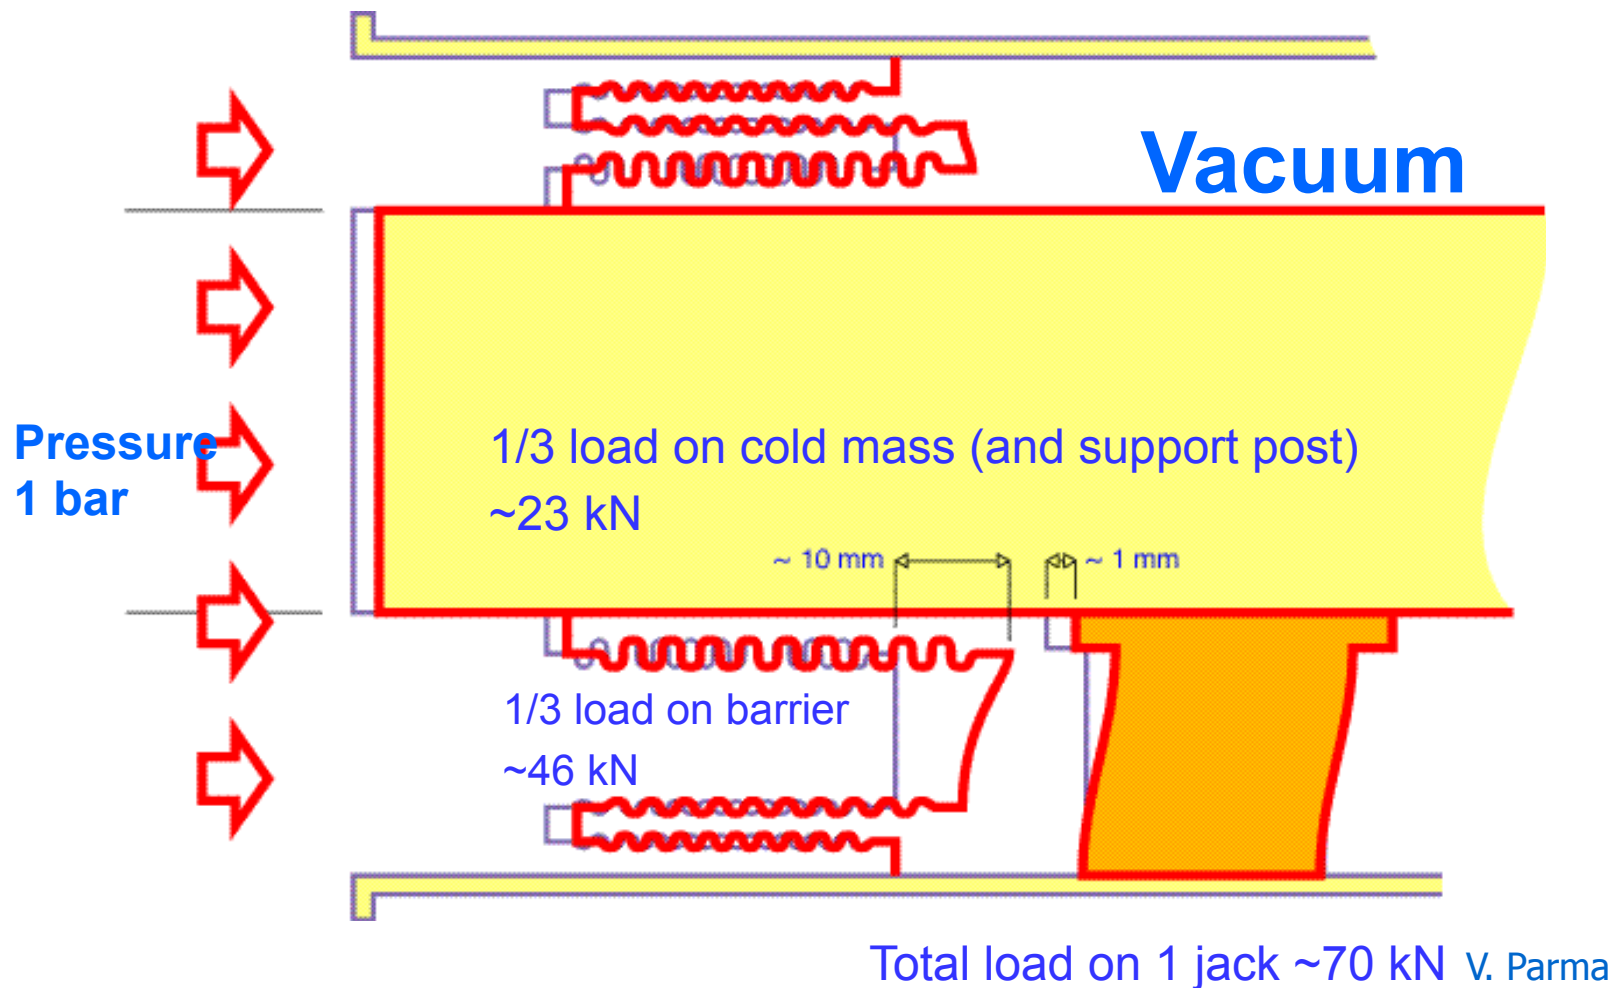
Pressure forces on SSS vacuum barrier

- Sector 3-4 was being ramped to 9.3 kA, the equivalent of 5.5 TeV
 - ◆ All other sectors had already been ramped to this level
 - ◆ Sector 3-4 had previously only been ramped to 7 kA (4.1 TeV)
- At 11:18AM, a quench developed in the splice between dipole C24 and quadrupole Q24
 - ◆ Not initially detected by quench protection circuit
 - ◆ Power supply tripped at .46 sec
 - ◆ Discharge switches activated at .86 sec
- Within the first second, an arc formed at the site of the quench
 - ◆ The heat of the arc caused Helium to boil.
 - ◆ The pressure rose beyond .13 MPa and ruptured into the insulation vacuum.
 - ◆ Vacuum also degraded in the beam pipe
- The pressure at the vacuum barrier reached ~10 bar (design value 1.5 bar). The force was transferred to the magnet stands, which broke.

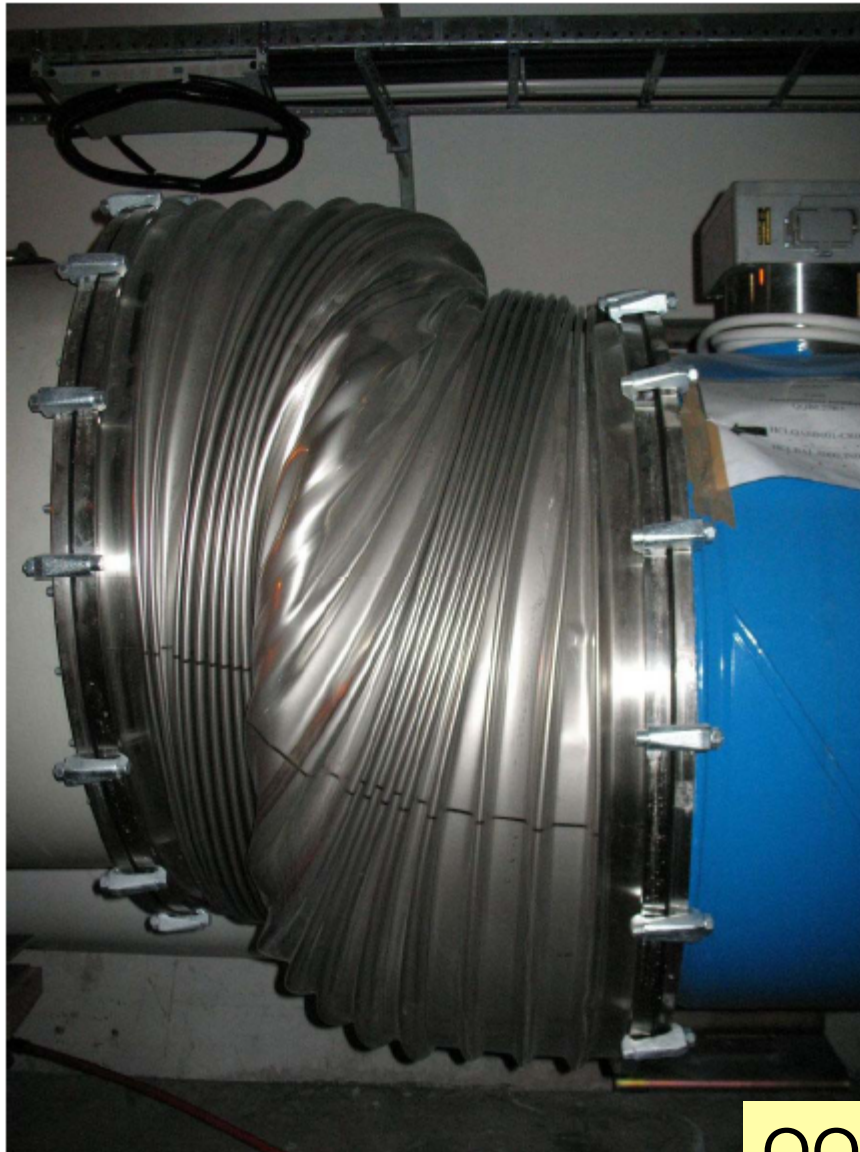
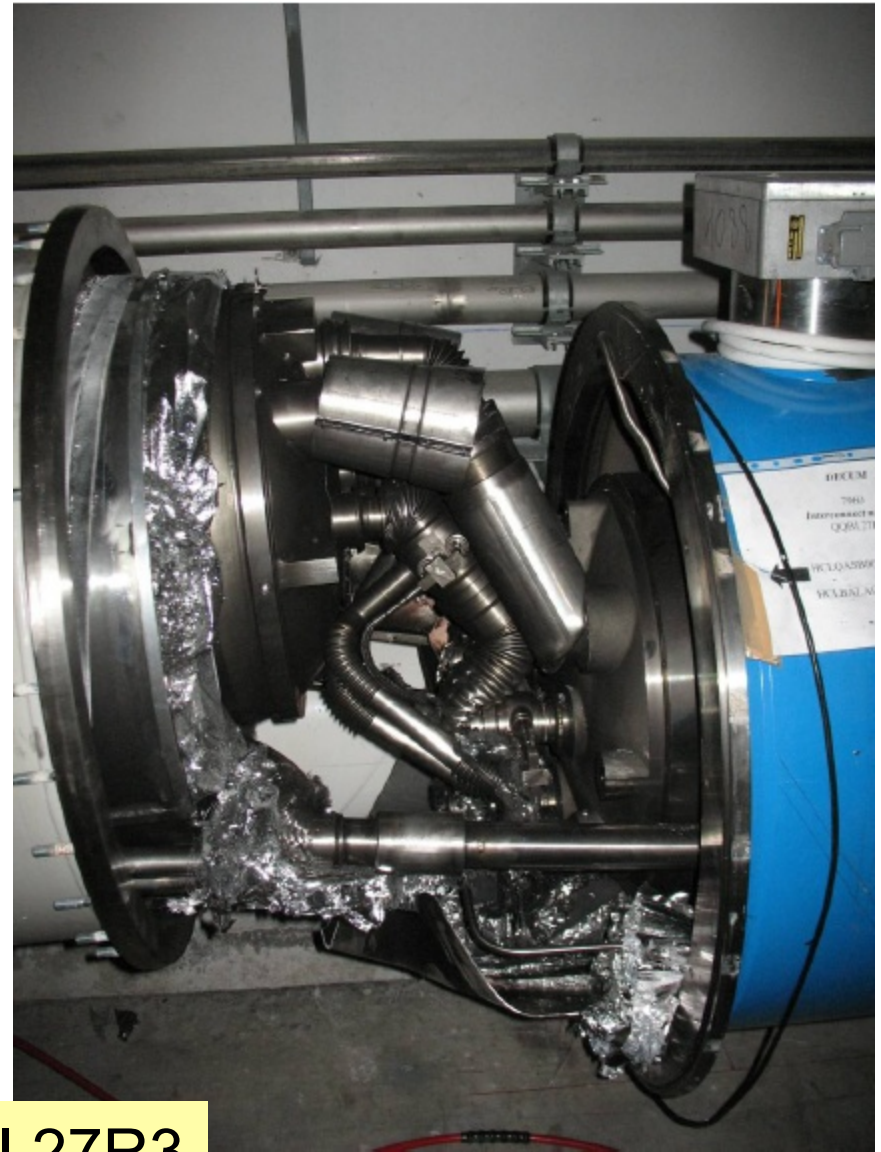
QQBI.27R3

Collimator damage: magnet displacements

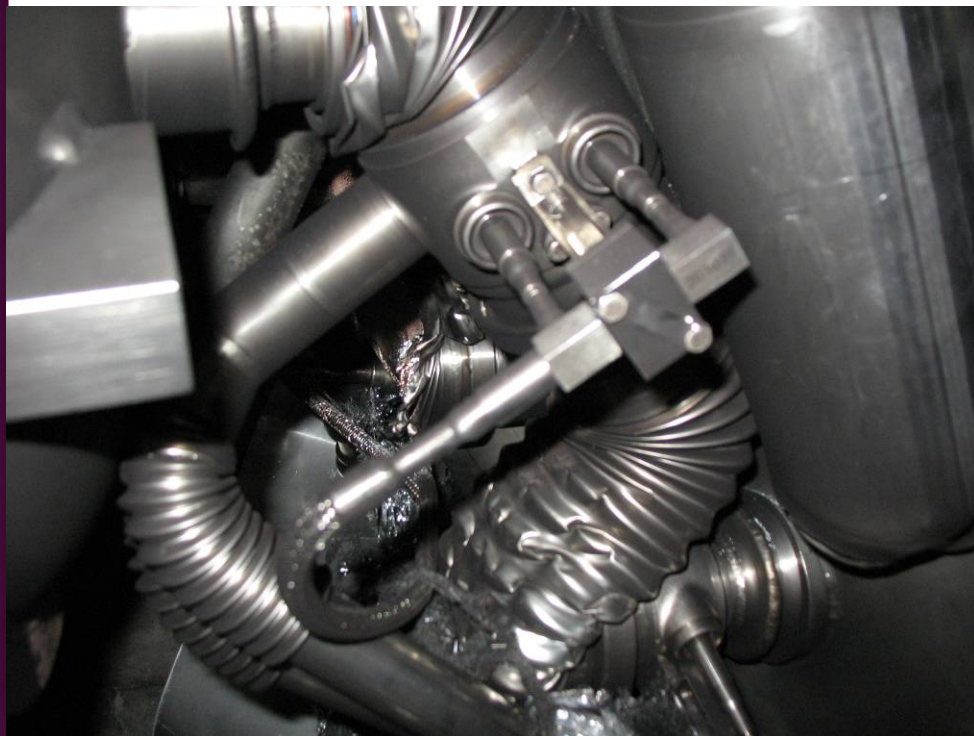
QQBI.27R3
N line

Collatoral damage: magnet displacements

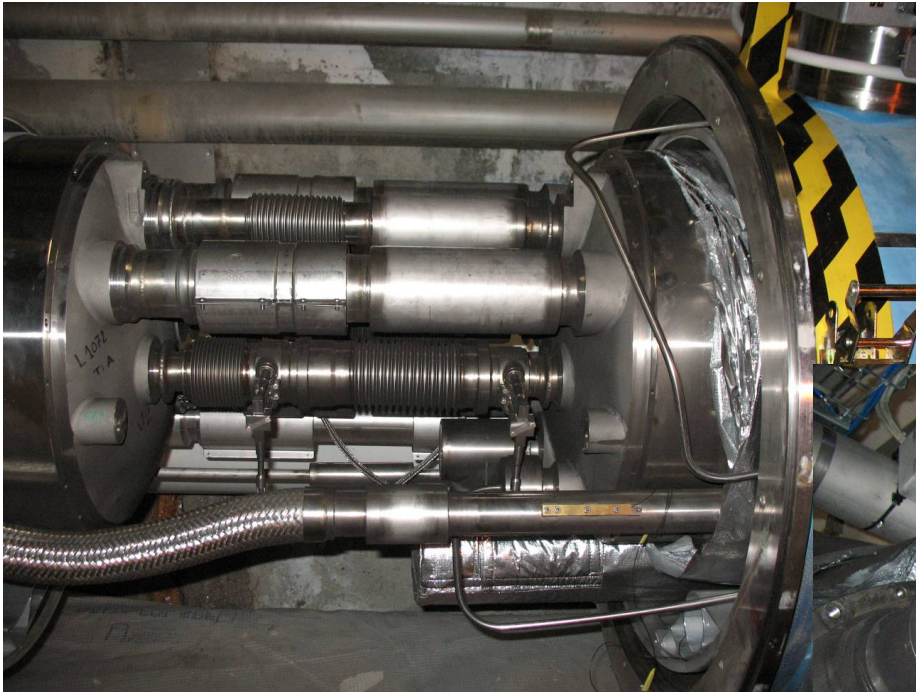
QBBI.B31R3
Extension by 73 mm

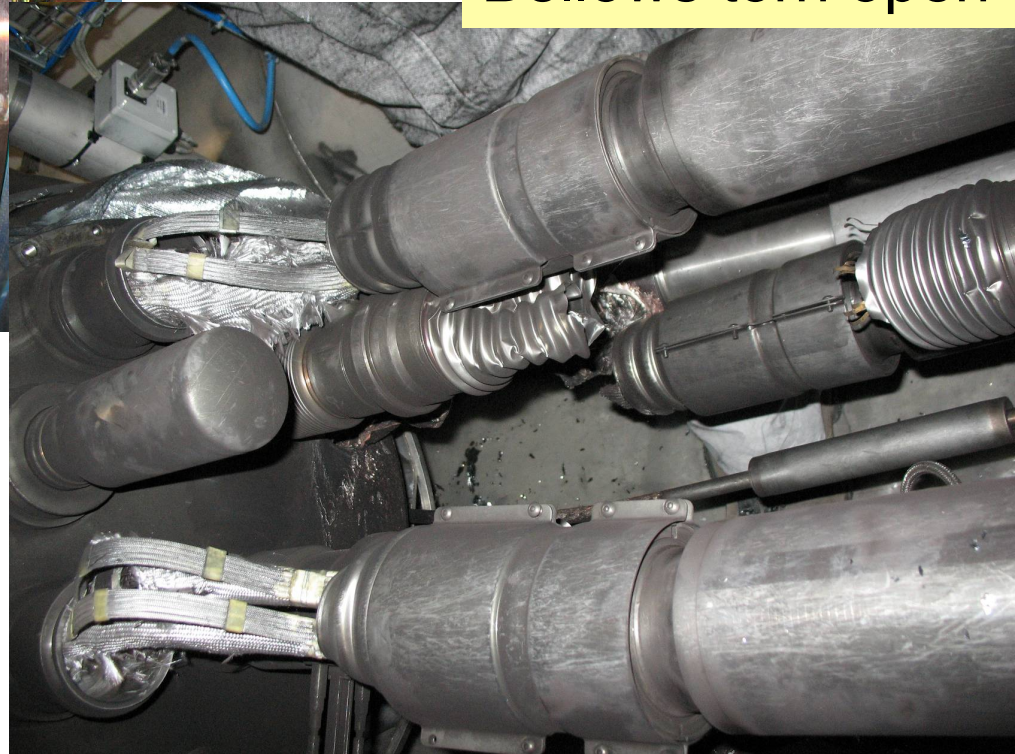
QBQI.27R3
Bellows torn open

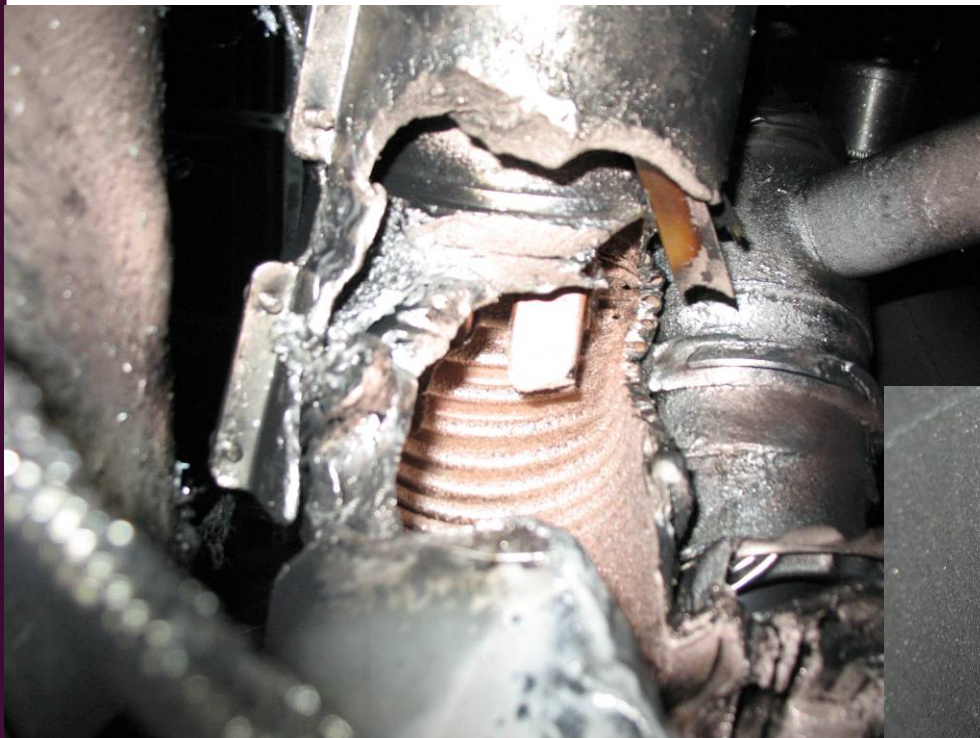
QBBI.B31R3 M3 line

Collateral damage: secondary arcs

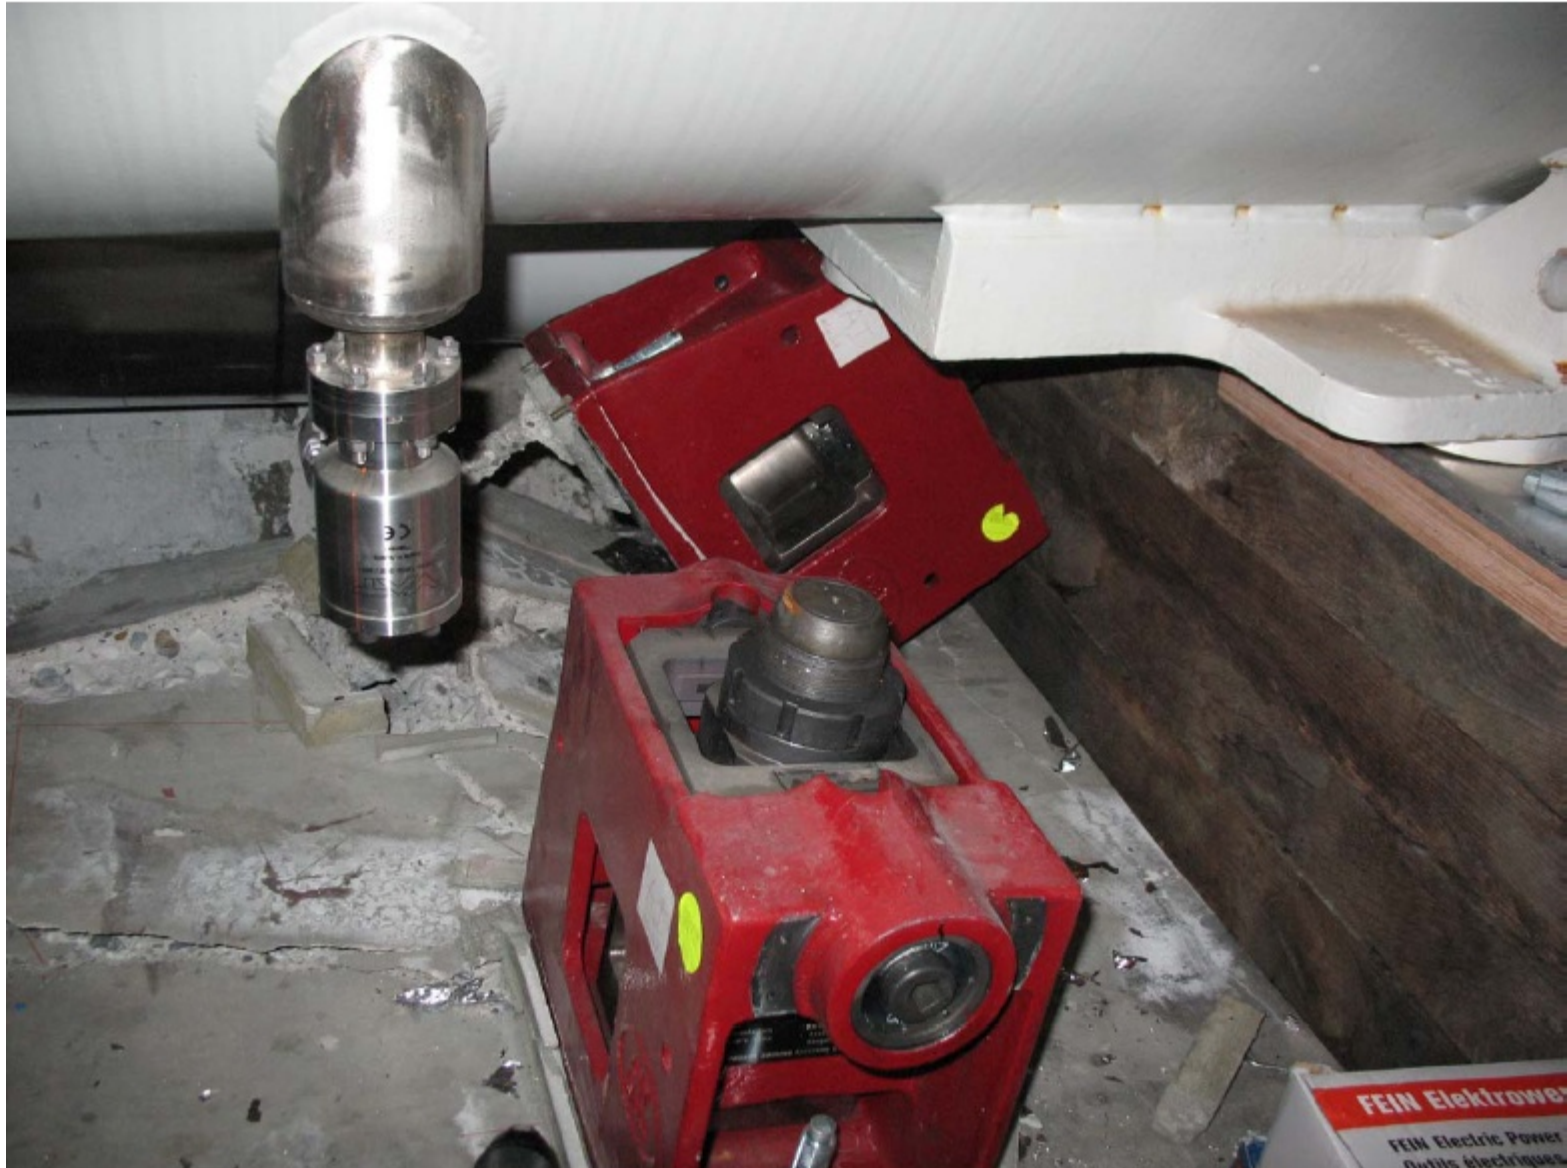
Collateral damage: ground supports

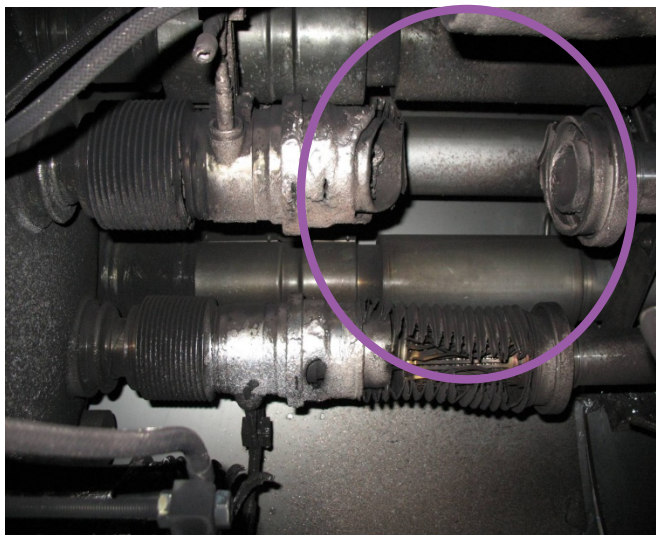
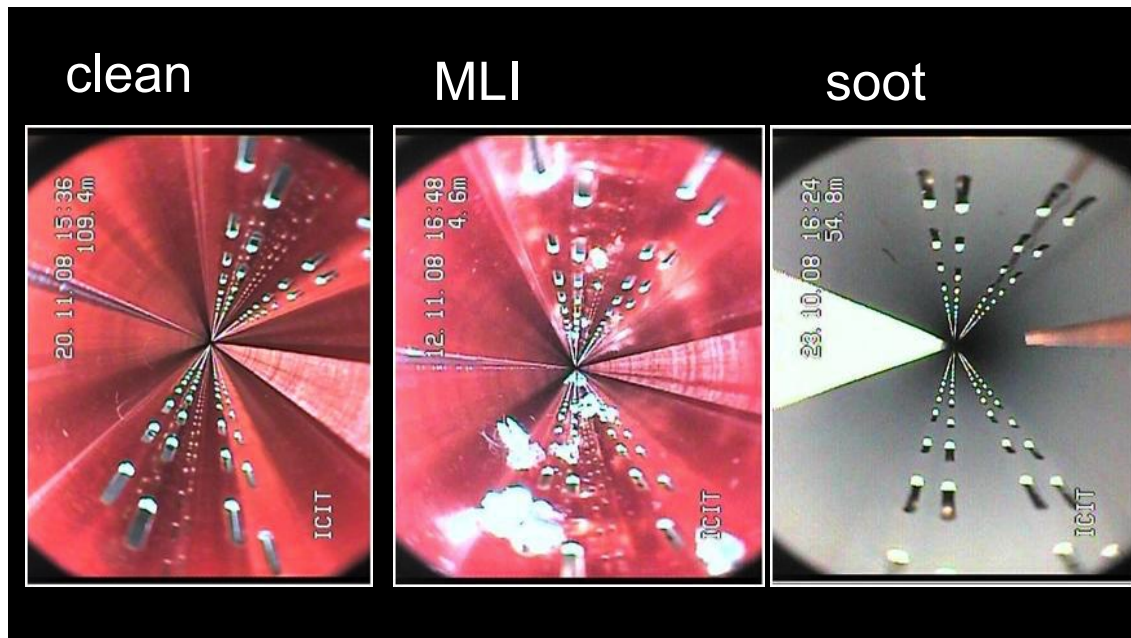
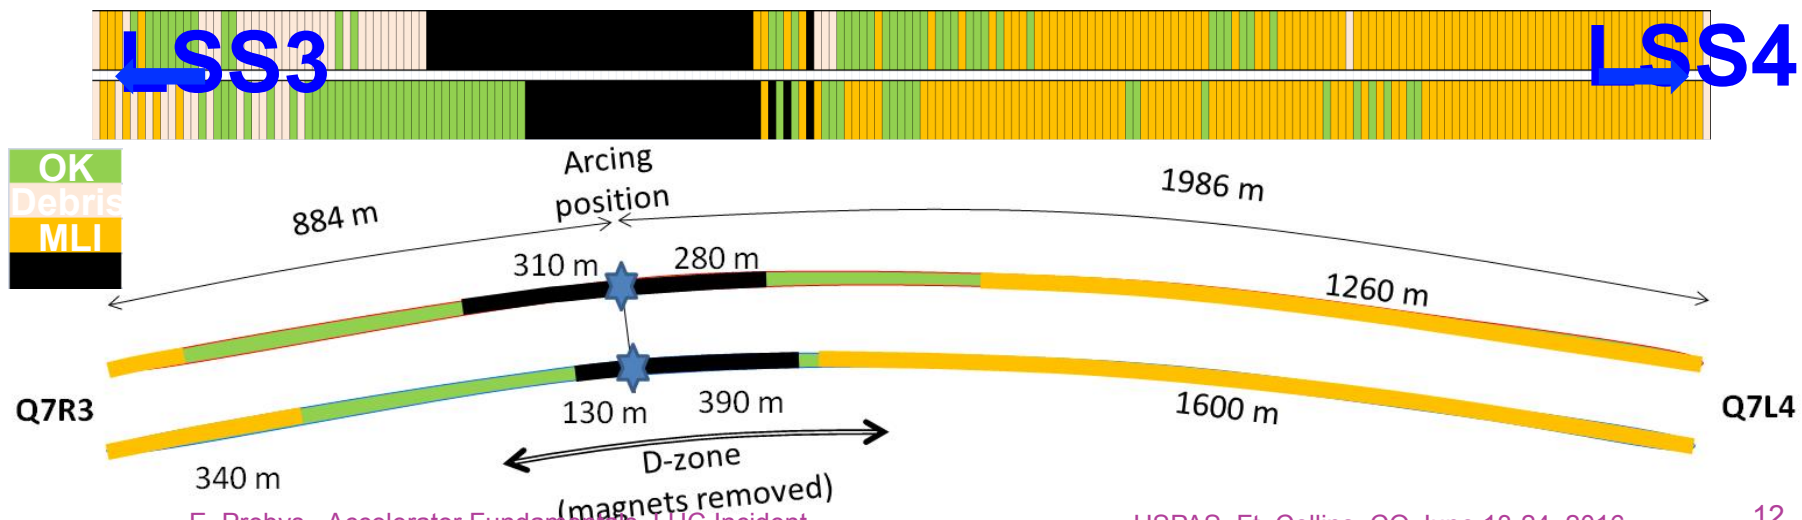
Collateral damage: Beam Vacuum

Arc burned through beam vacuum pipe

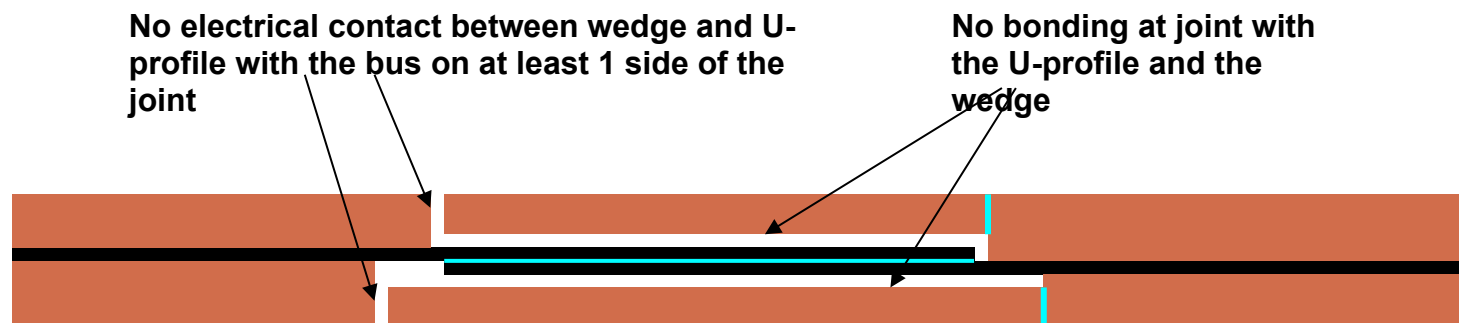
Theory: A resistive joint of about $220 \text{ n}\Omega$ with bad electrical and thermal contacts with the stabilizer

- Loss of clamping pressure on the joint, and between joint and stabilizer
- Degradation of transverse contact between superconducting cable and stabilizer
- Interruption of longitudinal electrical continuity in stabilizer

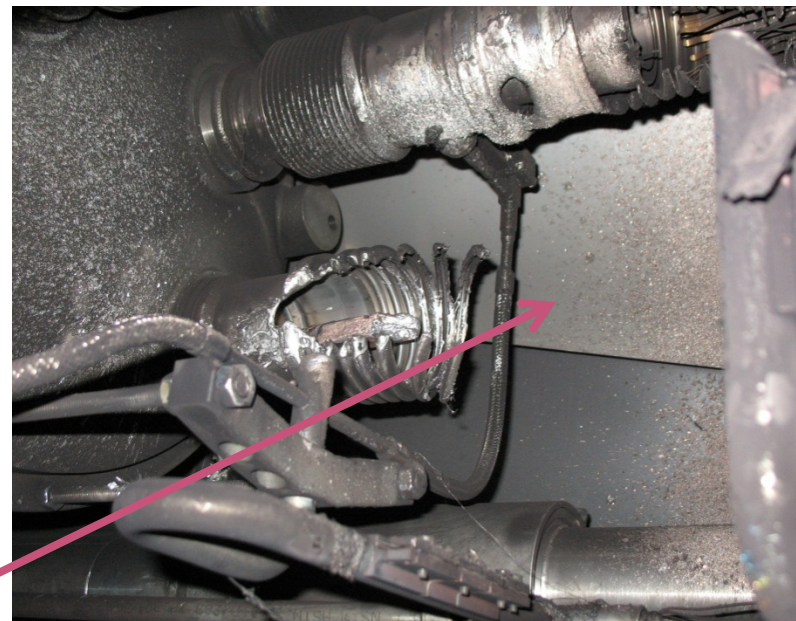
Problem: this is where the evidence used to be

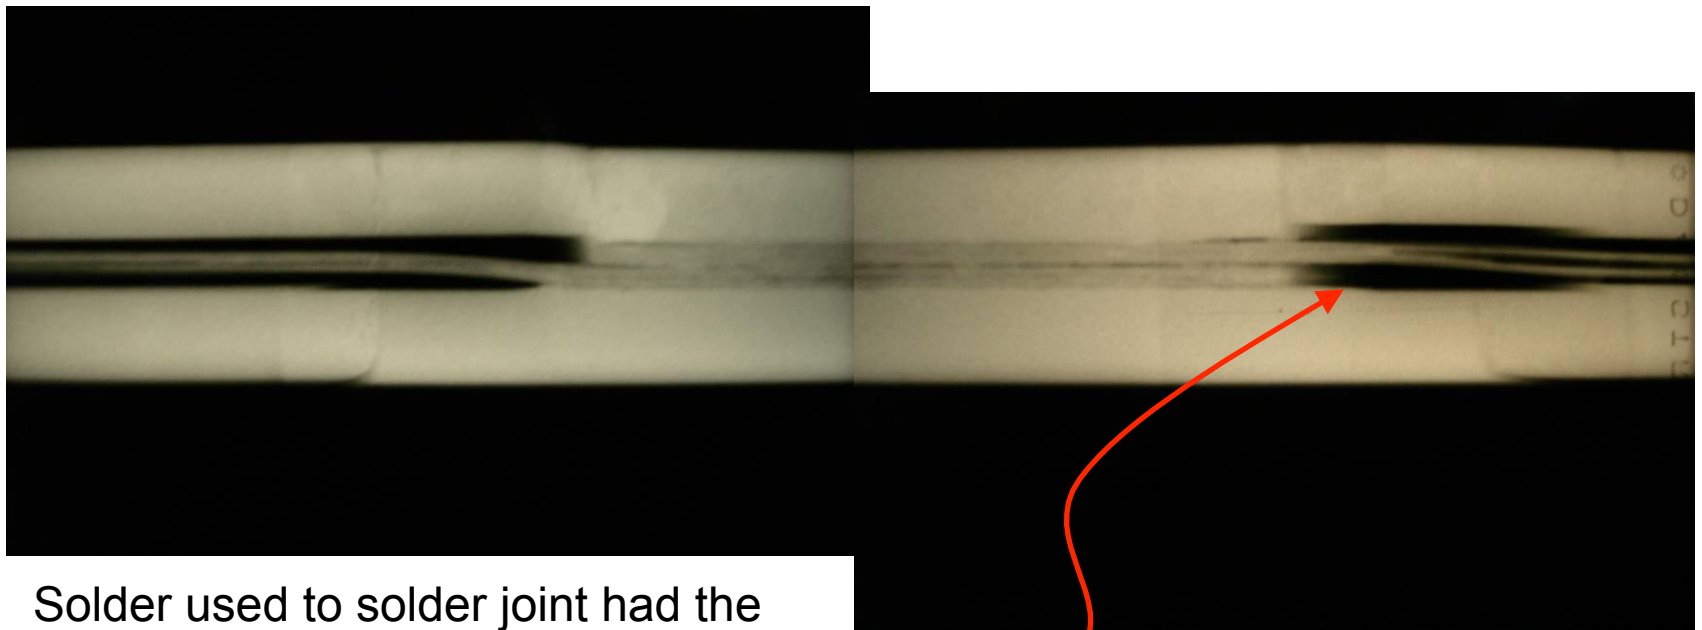
Solder used to solder joint had the same melting temperature as solder used to pot cable in stablizer

\Rightarrow **Solder wicked away from cable**

- Have to warm up to at least 80K to measure Copper integrity.

- All (10,000!) individual joints were rebuilt
 - ◆ Clamped
 - ◆ Inspected
- Improved pressure relief was installed to handle “Maximum Credible Incident” (MCI)
 - ◆ In which both the quadrupole and dipole Helium lines were burned through.
- After 2015 turn on, “smooth sailing”.
